# Coastal processes schools case study: Seaton in Cornwall

Working for the South West Regional Coastal Monitoring Programme, the Plymouth Coastal Observatory measures and records detailed information on more than 2,000km of England's coastline from the Severn Estuary to Portland Bill

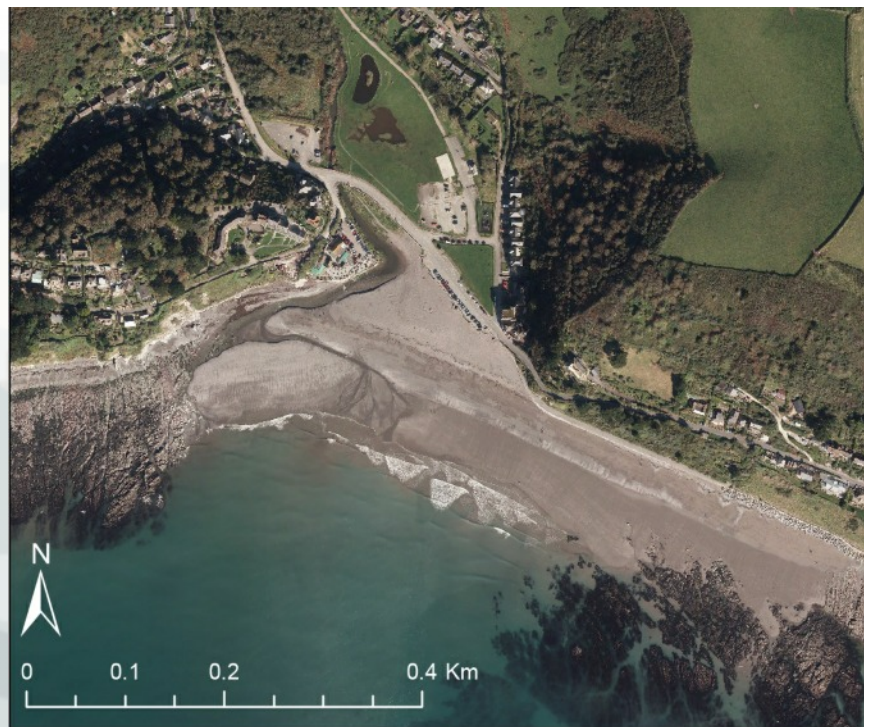
Look at the aerial photograph of the beach on the right – What feature is present which may have had a big impact on the movement of material on the beach? What conditions would you therefore expect to impact this beach in particular?

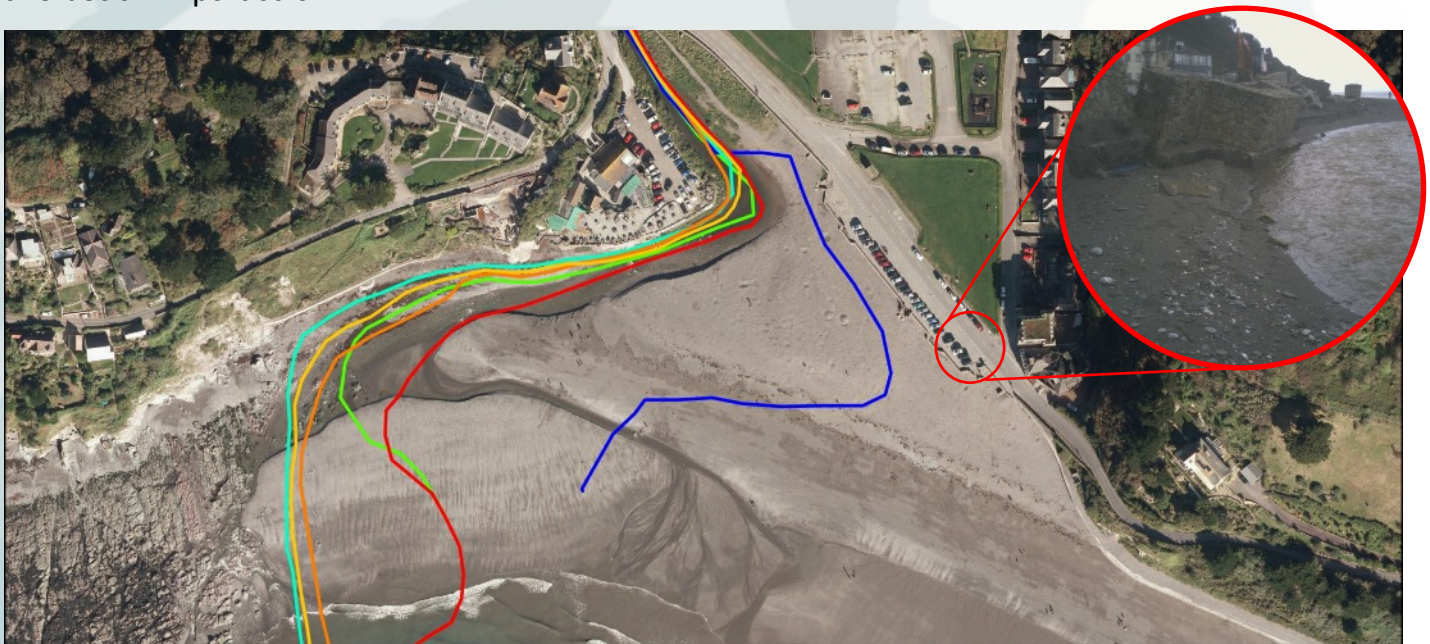
<p><b>Seaton River Course</b></p> <ul style="list-style-type: none"> <li>— 05/2014    — 01/2010</li> <li>— 03/2012    — 01/2009</li> <li>— 01/2011    — 02/2008</li> </ul>	<p>Aerial Photography from 2012</p>
--	--	-------------------------------------

**2** The PCO has been tracking the course of the River Seaton: the image above shows how its course has moved over time. In 2014 a sea wall in front of the car park at the beach collapsed, as can be seen in the inset photograph. Can you link the collapse of the seawall to the river in some way?

A series of aerial photographs commissioned by the PCO clearly shows how the course of the River Seaton moved rapidly eastwards across the town's beach between 2012 and 2014. Having previously been relatively stable between 2008 and 2012.

"We also operate a series of wave buoys and tide gauges around the region which recorded the ferocity of a series of storms which hit the area in late 2013 and early 2014. During one of the storms in January 2014, 100 metres of the seawall collapsed, in part due to erosion caused by the river running in front of it, and there was severe damage to nearby properties."

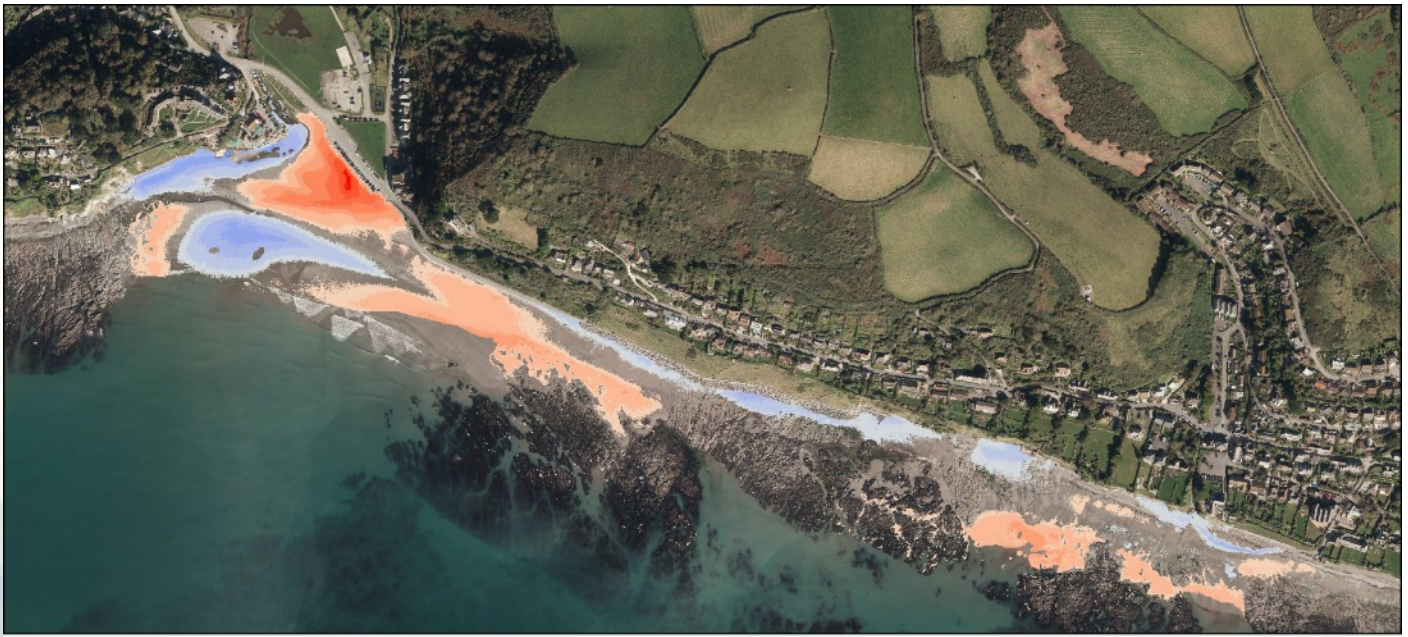
3 Above is a difference model of the beach – this shows the change in elevation of the sediment on the beach between 2008 and 2014. The model can be used to see how sediment has moved around the beach over time. Describe how the beach has changed between 2008 and 2014.”

Topographic measurements taken between 2008 and 2014 also show the level of the beach fell considerably just in front of Seaton's seawall, and rose at the foreshore.

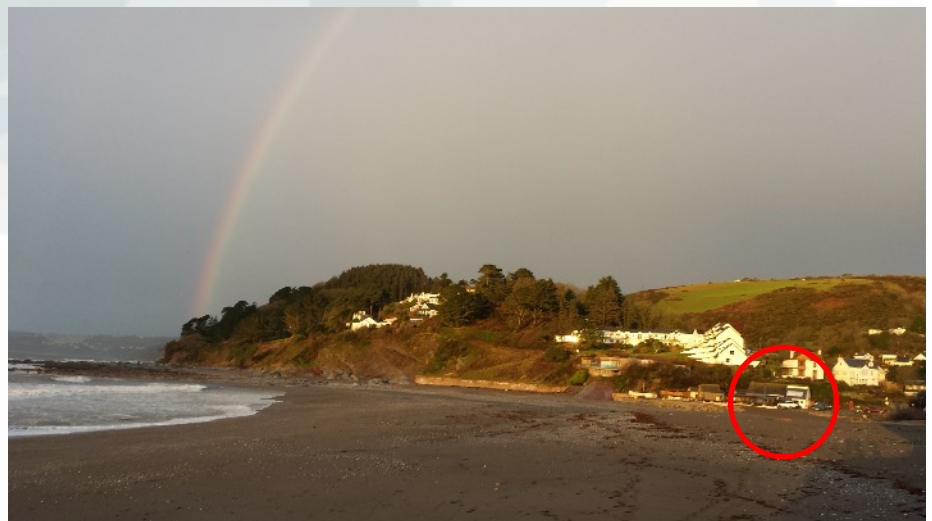
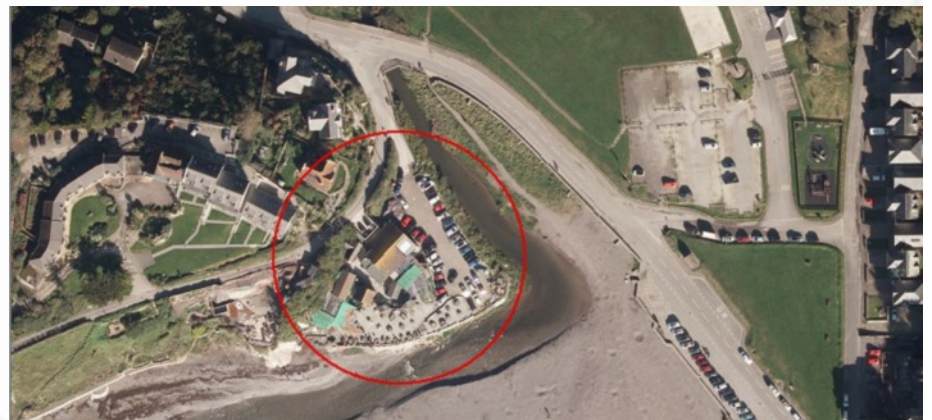
There is a café behind the beach which can be seen highlighted in the photographs on the right. Do you think the shape of the beach can have an impact on how storms and storm waves affect the café? Explain your answer.

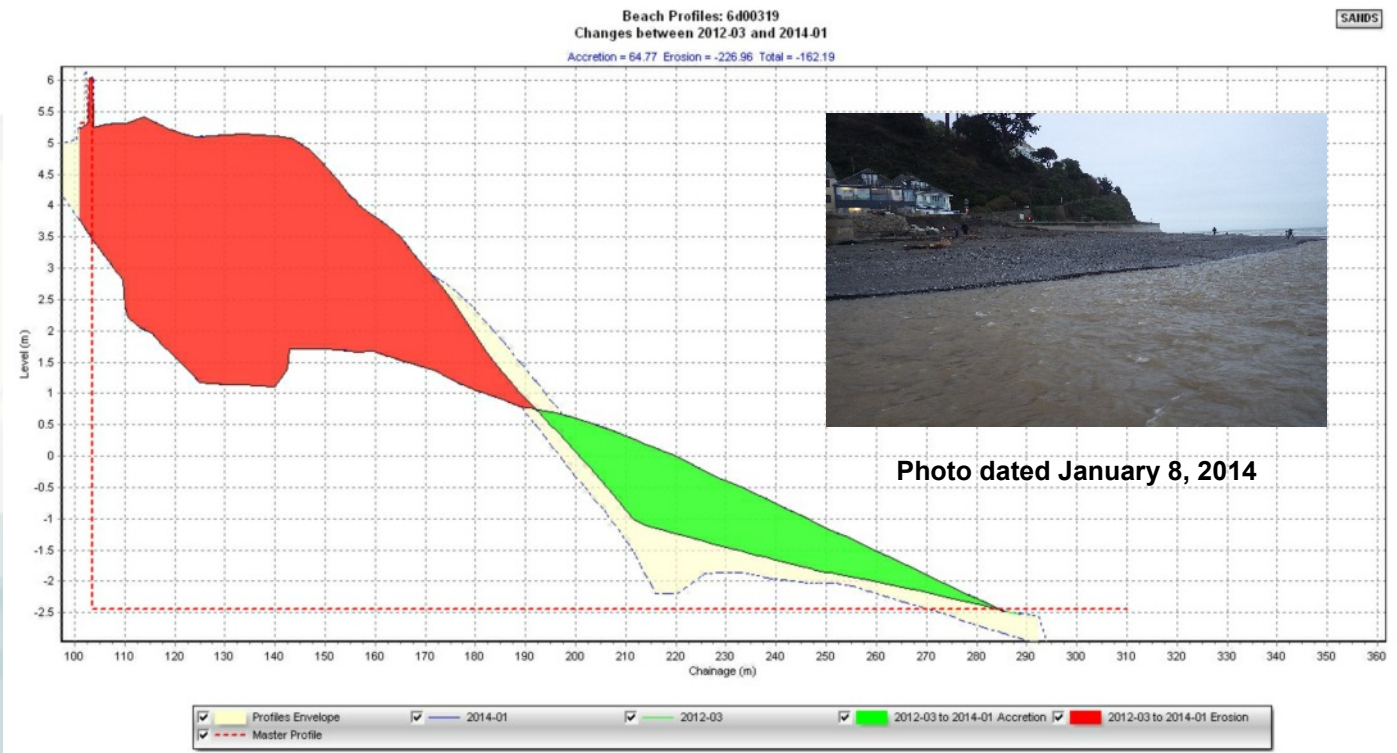
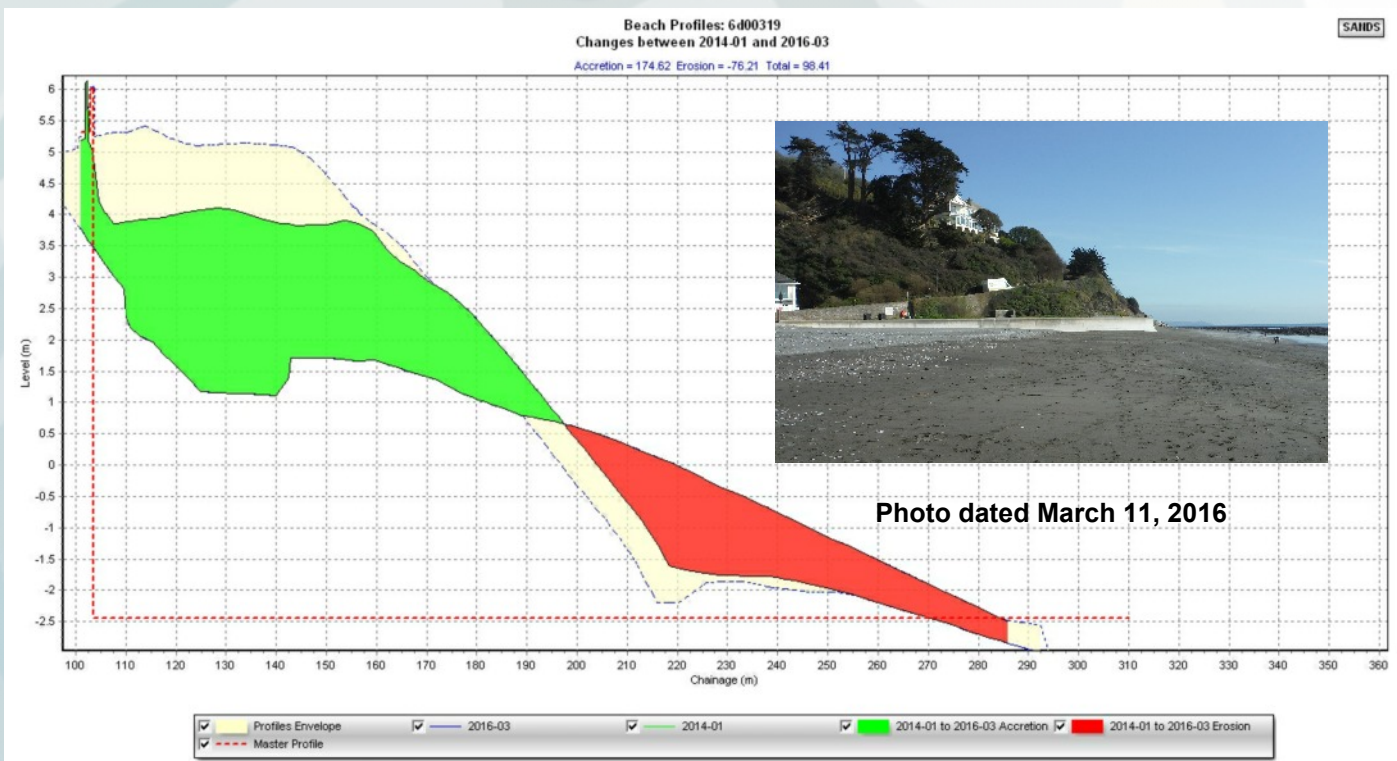
4 Take a look at these two beach profiles made by the coastal processes scientists at the Plymouth Coastal Observatory. The top one shows changes to the beach between March 2012 and January 2014. The red area shows erosion, the green area shows accretion. The lower one shows the changes between January 2014 and March 2016. The inset photographs were taken along the profiles. There were severe winter storms in late 2013-early 2014. What was happening to the beach in the years before the storms, and what impact do you think the storms had on the beach?

Since those storms, new defences have been built and beach reprofiling has taken place, returning it to its pre-storm condition, as can be seen when beach profiles taken by the PCO at various times are compared.
