# Coastal processes schools case study: Sidmouth in Devon

Working for the South West Regional Coastal Monitoring Programme, the Plymouth Coastal Observatory measures and records detailed information on more than 2,000km of England's coastline from the Severn Estuary to Portland Bill

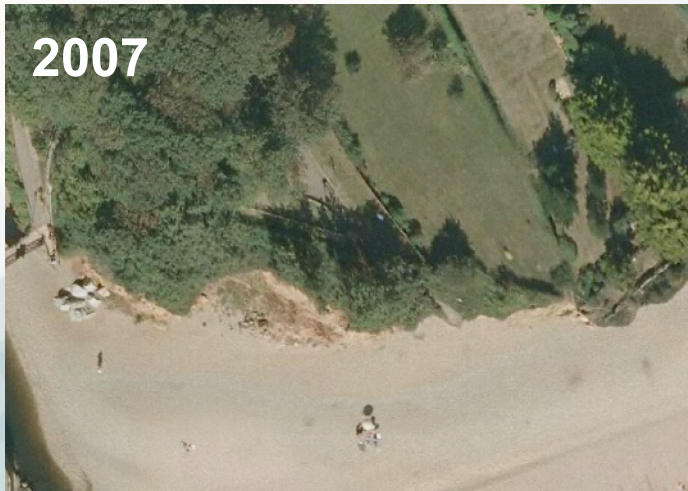
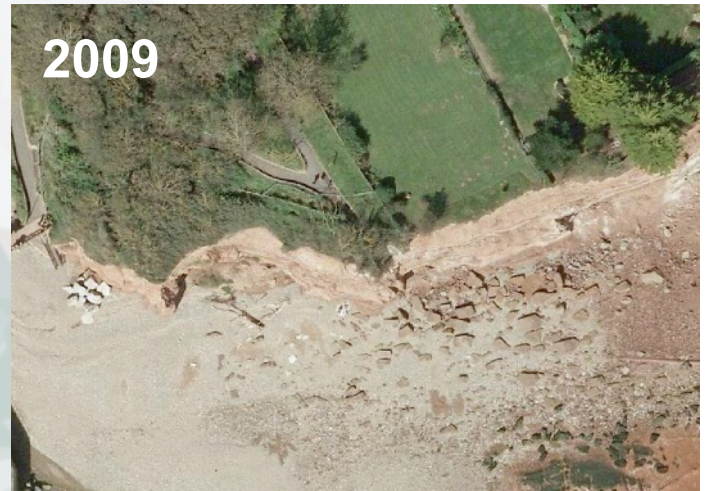
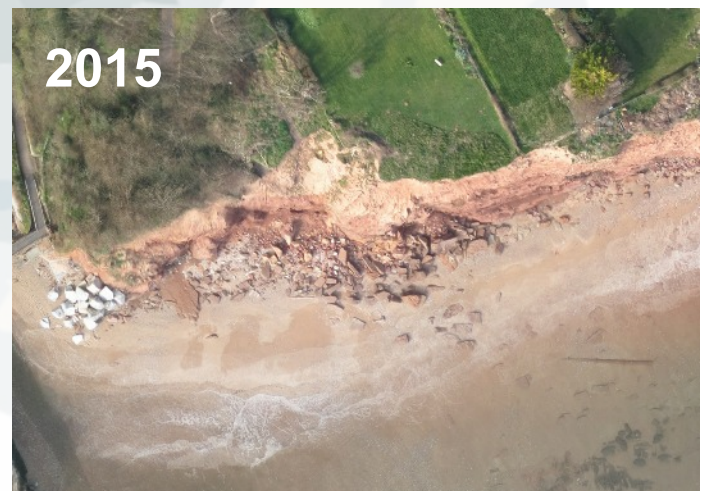
The images on this page and the next were taken by the PCO as part of their monitoring, and show the cliffs at Pennington Point.

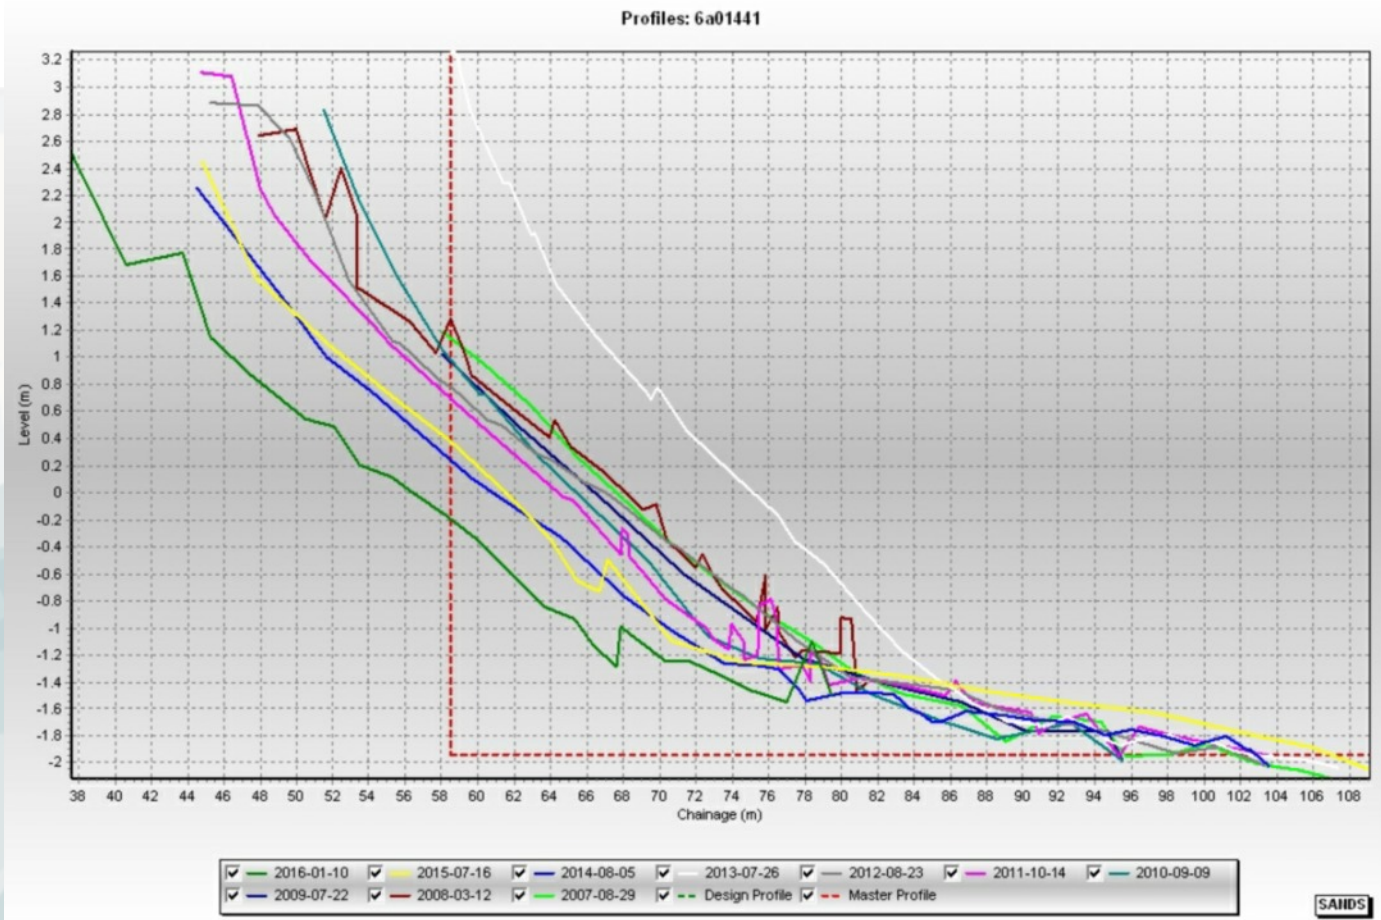
**7** At the top of the page is a graph showing changes to a beach profile from Pennington Point. The first profile is from 2007 (solid line in light green) and the latest is from January 2016 (solid dark green). The accompanying photos were taken on the same profile. Measuring from the master profile (broken red line) what has happened to the level of the beach between 2007 and 2016? Can you use the photographs to support your view?

The coast is divided into segments, so accurate measurements can be made from the same points time and again. This produces graphs called beach profiles, which again can then be used to show the changes taking place. Comparing profiles taken at Pennington Point at Sidmouth shows that the levels of the beach there have fallen – in some places by more than a metre – since 2007. The data also shows what happened after a large rock fall in 2012.

**8** What do you think happened between 2012 and 2013, where the beach appears to accrete dramatically? Where do you think this additional sediment came from?
