# The Dynamic Coast...

## The 'lost village' of Hallsands

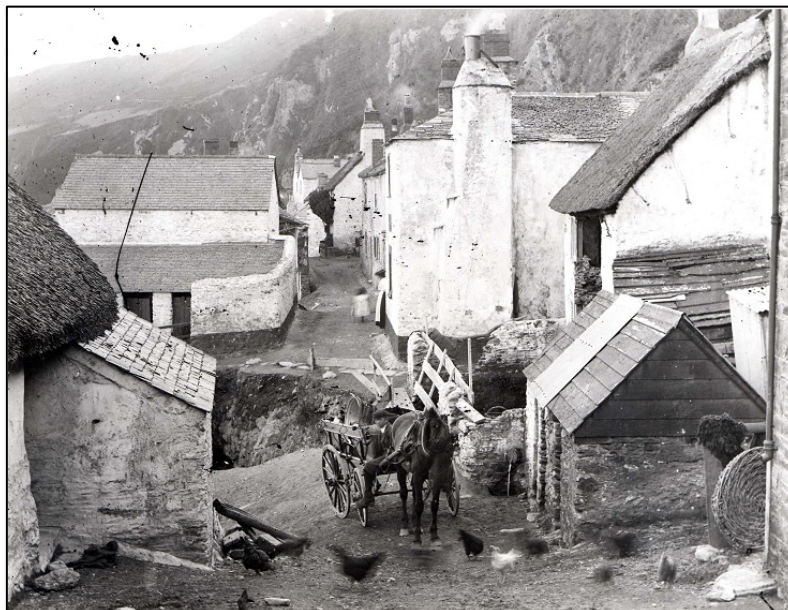
4. In 1904, severe storms battered the village. No longer protected by its extensive beach, waves pounded the rocky platform eroding a huge chasm. High waves damaged several houses. The photo below was taken between 1904 and 1917.

- (a) Use a labelled arrow to show the location of the eroded chasm in the photo.
- (b) Give three pieces of evidence that the village was still occupied despite the damage that was caused by the 1904 storms.

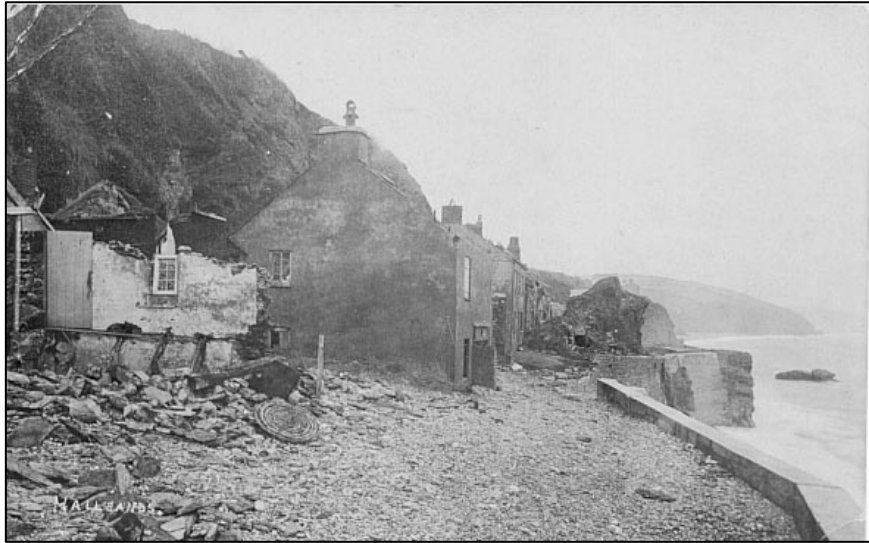
5. On 26 January 1917, much of the village of Hallsands was battered by storm waves. Whilst nobody died, the village was destroyed. The photo below shows the scene after the storm.

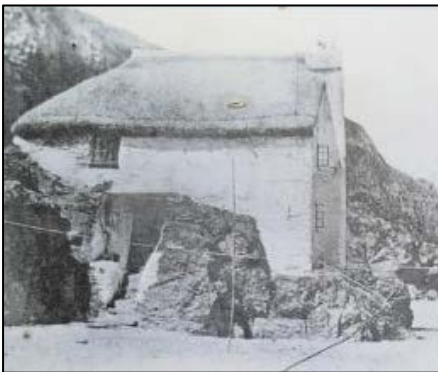
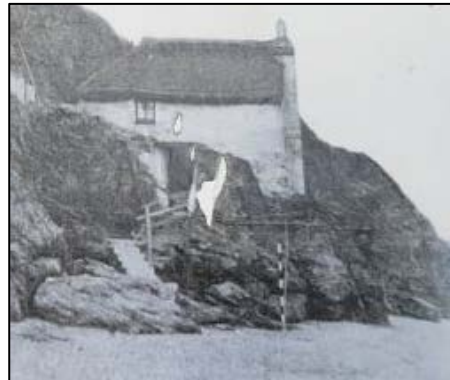
6. The cause of the disaster at Hallsands was the erosion of the village's protective beach.
- (a) Look at the two photos below. They show changes in the height of the beach over a period of a few decades at the turn of the 20<sup>th</sup> Century. Draw a line on the right-hand photo to show how much it has fallen since 1897.

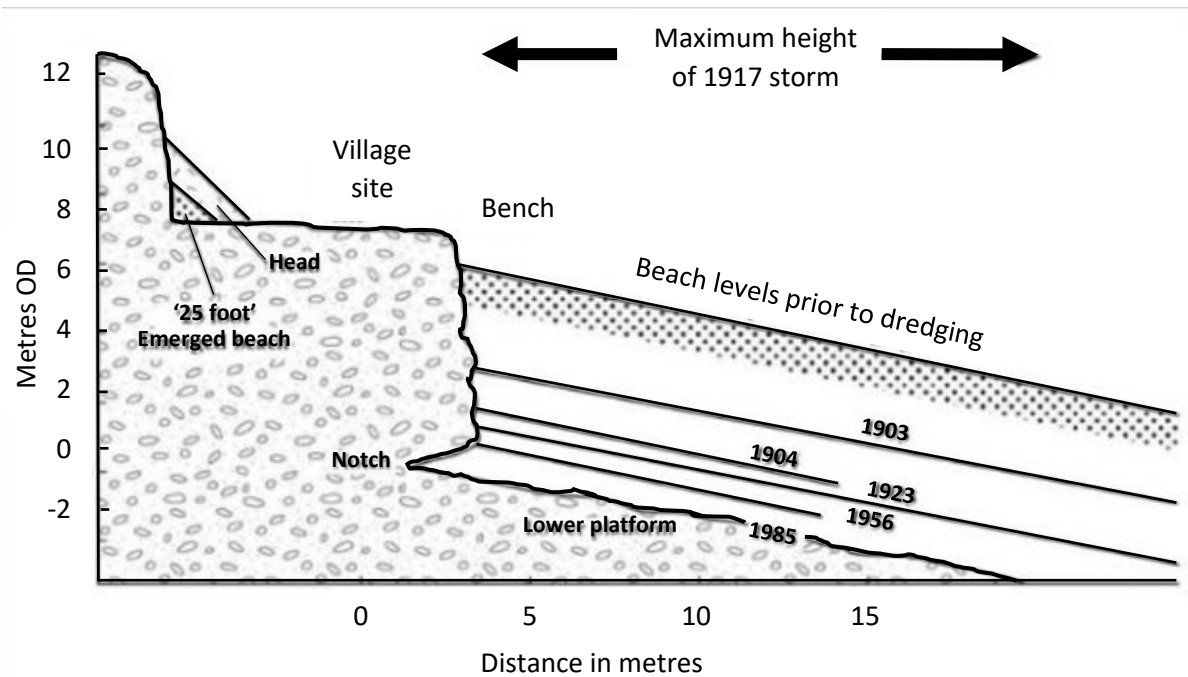
7. The diagram below is a cross section showing the site of the village on the rocky platform and the beach. Notice how the height of the beach fell after dredging started.

(Source: Mottershead, 1986)

The vertical scale shows height - 0 is sea level.

'Head' describes sediment formed by frost weathering and slumping during colder climatic conditions that has collected at the foot of a cliff.

- Use a colour to shade the solid rock cliff.
- What was the highest level of the beach prior to dredging? \_\_\_\_\_ m
- By how much had the beach fallen by 1903? \_\_\_\_\_ m
- What maximum height above sea level were the 1917 storm waves? \_\_\_\_\_ m
- What is the evidence that the absence of a beach has resulted in the erosion of the rocky platform?
