# Storm Desmond Flood December 2015

#### What were the impacts of Storm Desmond?

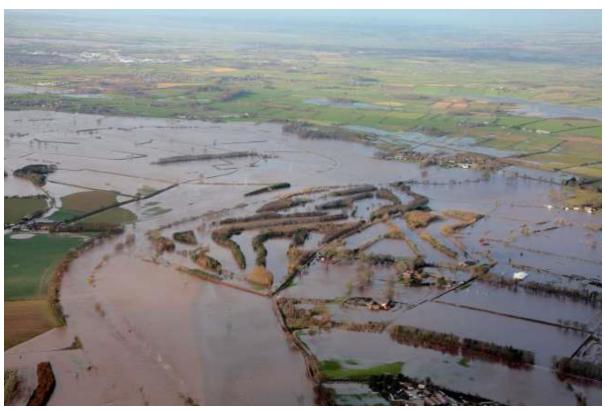
- The flooding at Low Crosby on the 5<sup>th</sup> and 6<sup>th</sup> December 2015 as a result of Storm Desmond, was unprecedented.
- The flow of the River Eden towards Carlisle on the 6<sup>th</sup> December was the highest ever.
- Flood levels reached 0.6m higher than the previous record set in January 2005.

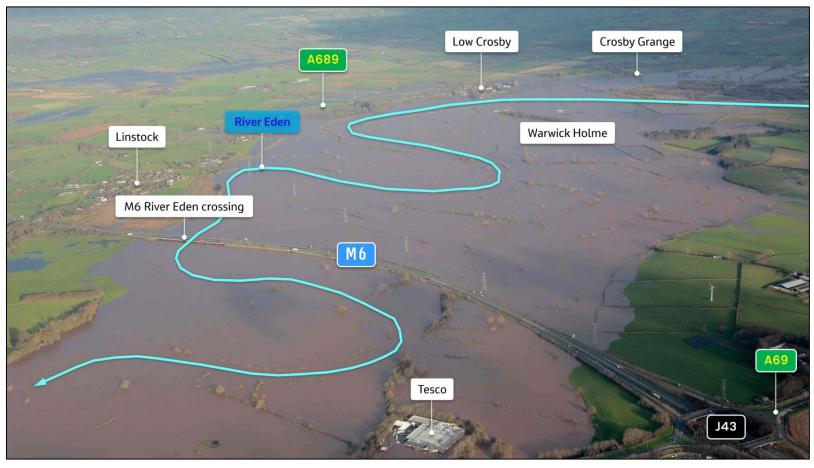
### Flooding of the Eden Valley, 2015

This aerial photo shows the extensive flooding of the River Eden valley. The blue line shows the normal course of the river. Locate Low Crosby – notice that it is surrounded by water.

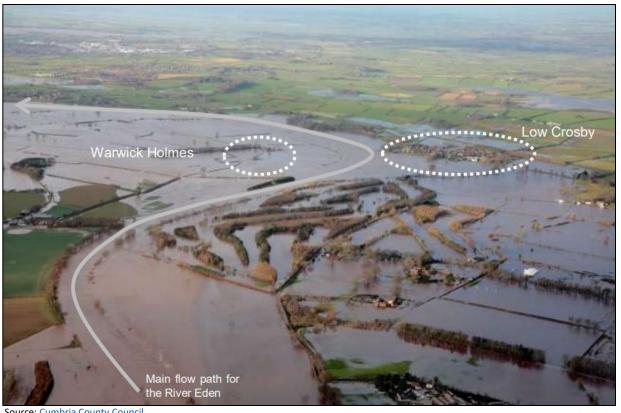
- Approximately 60 properties experienced internal flooding.
- Nearby rural properties were also flooded (e.g. Warwick Holmes and Newby Grange).
- Large areas of agricultural land were flooded, for example, at Warwick Holmes.
- Sections of road became impassable including the A689.
