## Coastal processes schools case study: Dawlish Warren

Working for the South West Regional Coastal Monitoring Programme, the Plymouth Coastal Observatory measures and records detailed information on more than 2,000km of England's coastline from the Severn Estuary to Portland Bill

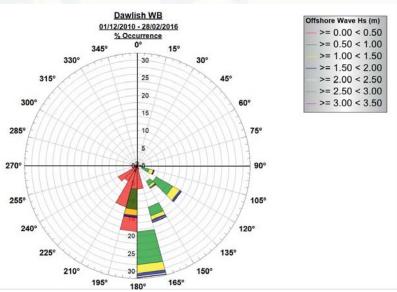
Dawlish Warren (above) is a geographical spit feature that protrudes into the mouth of the River Exe on the south coast of Devon. Located on an exposed piece of coast and at the mouth of a large river there are a lot of processes which influence the size and shape of the spit. The wave rose (right) shows the direction that waves come from at Dawlish, do you know how this might help the building of the spit?

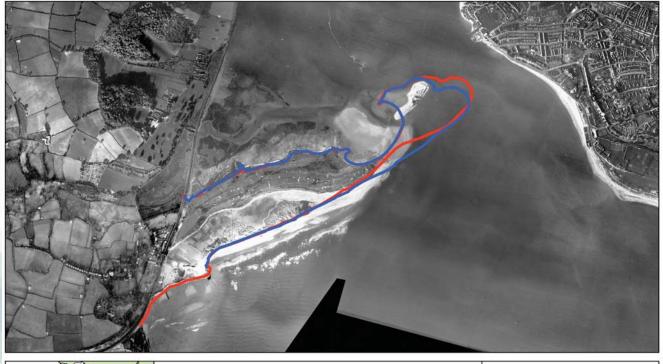
Because Dawlish Warren is in such a dynamic area it is constantly changing size and shape. The image on the next page was taken in 1947, how has the spit changed since then? Does this confirm your thoughts on the building processes?

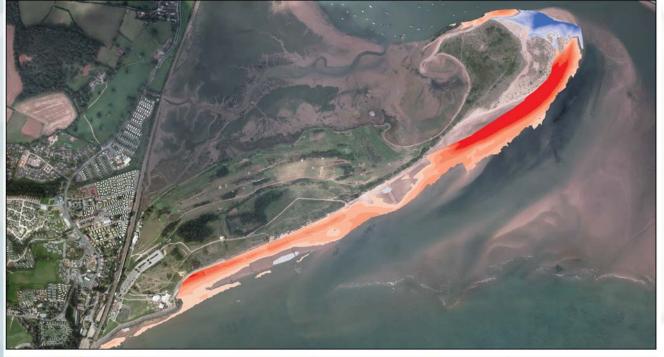
Change in Elevation (m) between Baseline 2007 and June 2016

By comparing historic and modern aerial imagery it can be seen that the natural input of material has allowed the spit to grow considerably over the last 60 years. However the building of sea defences to protect other areas of the coast have limited the availability of material. Analysis of data collected over the last 10 years by PCO shows the areas of the spit which are eroding and accreting.

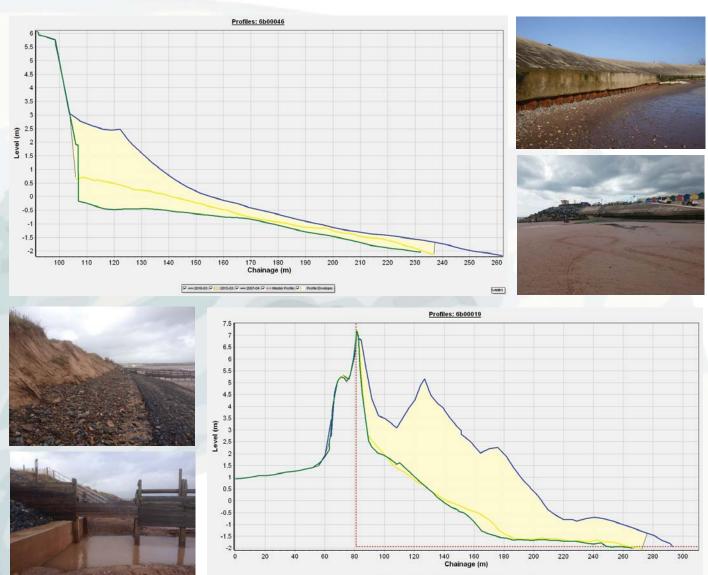
Look at the two profiles of beach shape above. The top profile is situated infront of a seawall. In what way has the beach changed shape and how might this effect the seawall? The bottom profile is infront of a dune, where do you think the material may have gone?
